REPORT

**CURRENT STATUS OF MITHI RIVER
AND POSSIBLE SOLUTIONS**

**National Environmental Engineering
Research Institute**

January, 2011

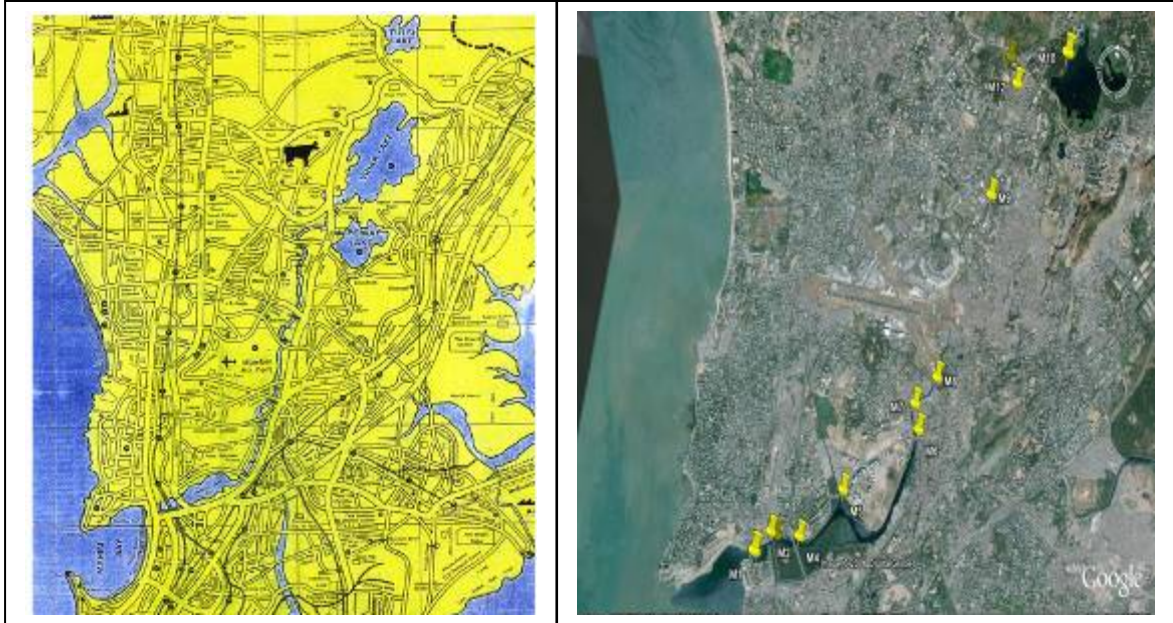
Figure 1 : Map of Mithi River

Mahim bay area, where Mithi river meets Arabian sea, is a nominated bird sanctuary called “**Salim Ali Bird Sanctuary**” where migratory birds come for nesting. This part is full of mangroves constituting a very rich but fragile ecosystem. **Figure 1** shows the map of Mithi River.
